## Ultrasonographic Evaluation of Hernioplasty of Experimentally Induced Large Ventro-lateral Hernia in Bucks

### Summary

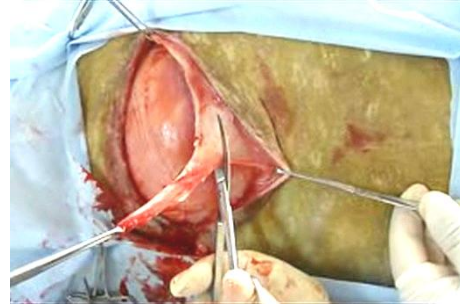
**Fig.2-** The abdominal muscles are opened and cutting off part of them.

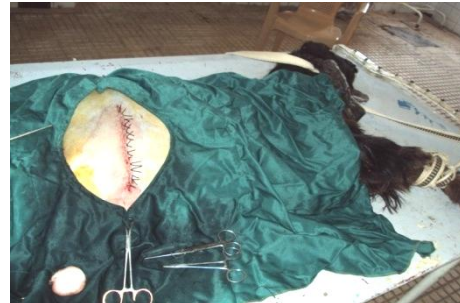
**Fig.4-** The skin is sutured with interrupted horizontal mattress by silk (no.1).

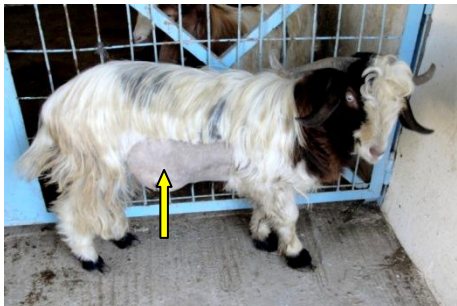
**Fig.5-** Artificial Vento-lateral hernia in buck (arrow)

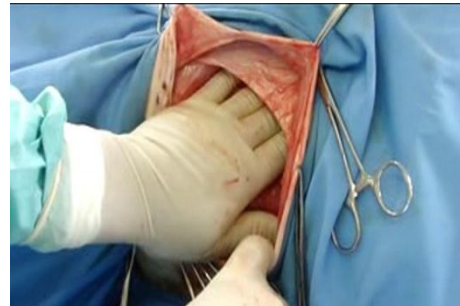
**Fig.6-** The hernia ring is detected by manual palpation.
